### **ADVANTAGES OF ALUMINUM AS A BUILDING MATERIAL**

## **CORROSION IN ALUMINUM**

# SOLVING REFINERY CORROSION PROBLEMS WITH ALUMINUM

### THE SURFACE OXIDE FILM ON ALUMINUM

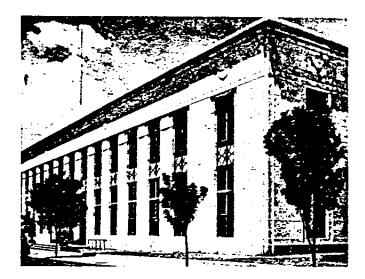
Figure 15—U. S. Government building at Key West, Florida, erected 1932, using windows of extruded aluminum alloy (alloy 43). The seaside conditions prevailing at Key West have had little effect on these unpointed aluminum windows. This photograph, taken in 1944, illustrates the non-staining characteristics of aluminum alloys.

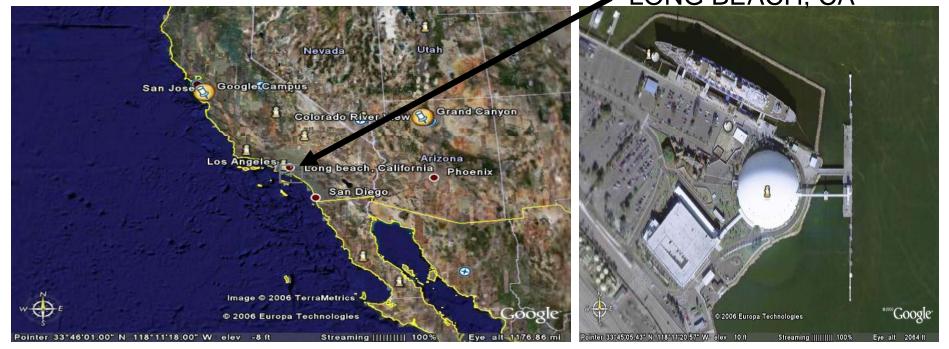
Temcor has installed over 7000 aluminum domes in a variety of environments throughout the United States, and the world. In every case, the all aluminum construction has not been affected by marine atmospheres In February 1982, Temcor completed a 126.5 meter aluminum dome in Long Beach, California that was used for a time to house the "Spruce Goose", Howard Hughes' large airplane. The dome is still as maintenance free as the day it was built. In addition, aluminum was preferred as the airplane had been housed in a hanger skinned with 3003 aluminum sheet, the same alloy Temcor uses, for over 35 years in a nearby area. There was no evidence of corrosion despite Long Beach's heavy marine and industrial atmosphere.

After the Spruce Goose was removed, the dome was used as a giant <u>movie</u> set for <u>films</u> such as "*Batman*" and "Pirates of the Caribbean" (see <u>http://www.seeing-stars.com/imagepages/QueenMaryDomePhoto1.shtml</u> The dome is currently use as Terminal for the Carnival Cruise Line's. See <u>http://california.construction.com/features/archive/0305\_CvrQueenMaryDome.asp</u>

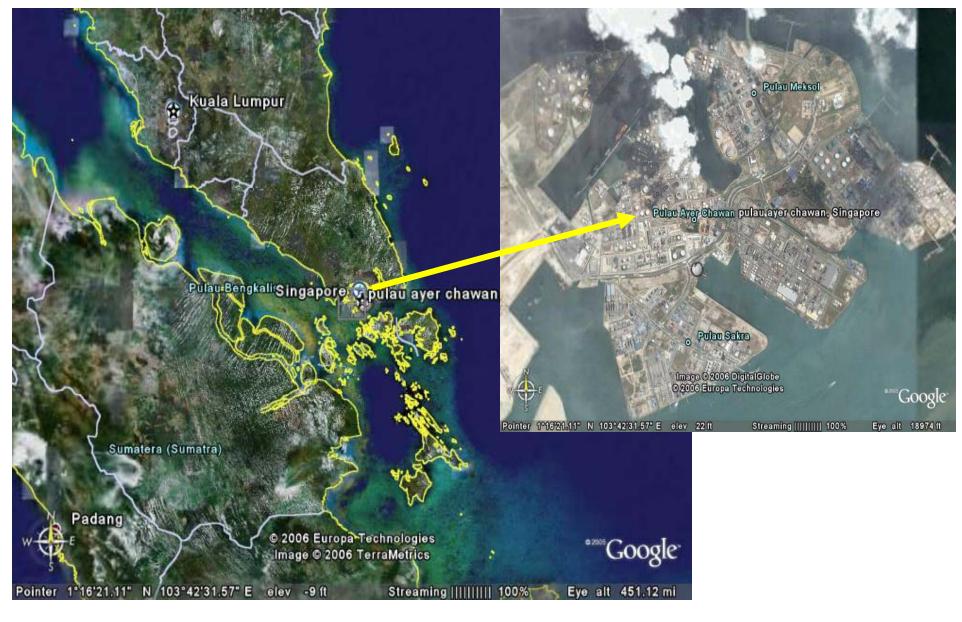
# ESSO Pulau Ayer Chawan SINGAPORE

Esso Singapore 45.4m Fuel Oil Storage Tank; conversion from steel cone roof to aluminum dome; completed January, 1997.

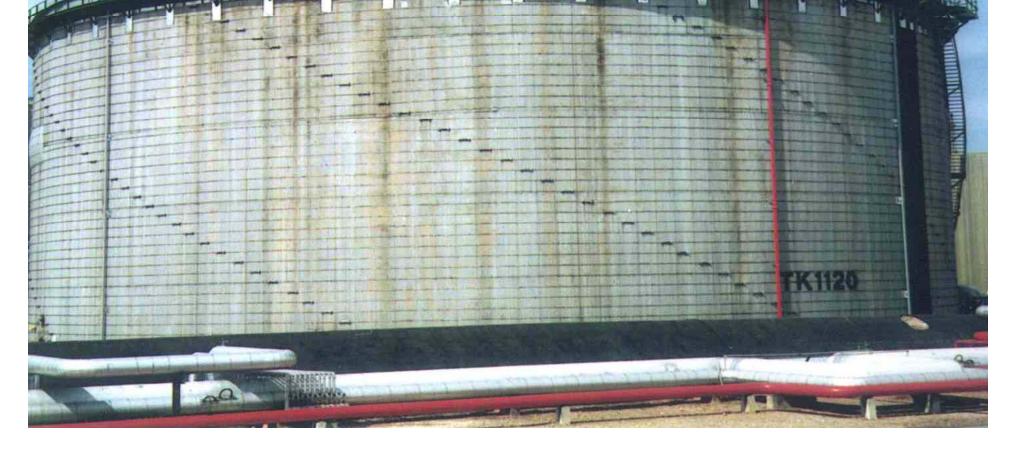
## Esso, Singapore 1995 Aluminum Dome. Diameter: 52.5m Application: Tank storing Fuel Oil

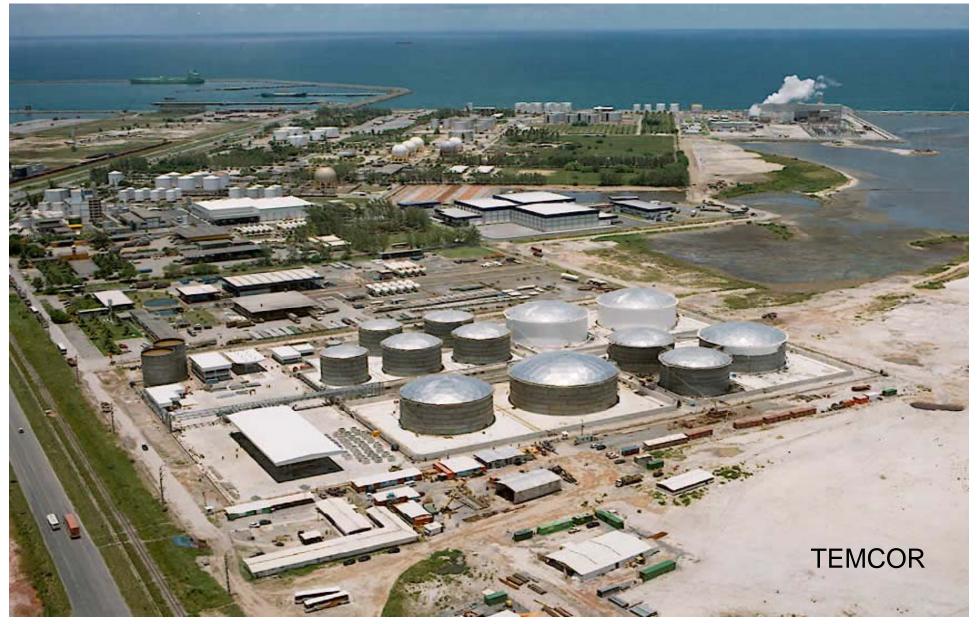
## DECAL. TERMINAL IN RECIFE, BRAZIL PICTURE DURING CONSTRUCTION. YEAR 2003

## DECAL. TERMINAL IN RECIFE, BRAZIL. Storing Diesel, alcohol & gasoline 13 ALUMINUM DOMES: 1-45.6 M, 2-41.7 M, 2-40.3 M, 2-30.4 M, 2-27.4 M, 1-24.8 M, 2-21.3 M & 1-8.0 M

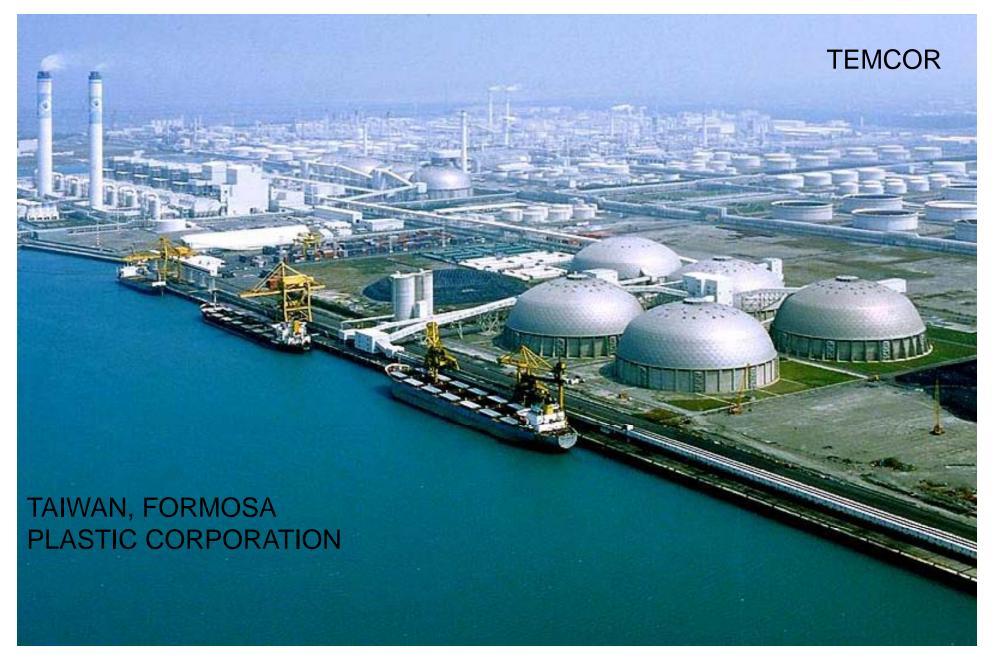
11 ALUMINUM DOMES STORING SALT & COAL 6-120 M Built in 1996, 4-120 m Built in 1998 & 1-120 m Built in 2002
